Vulnerability of Historic Religious Buildings in Nera's Valley, Italy

Marco Corradi¹, Giulio Castori¹, Antonio Borri¹, Romina Sisti¹, Alessandro De Maria²

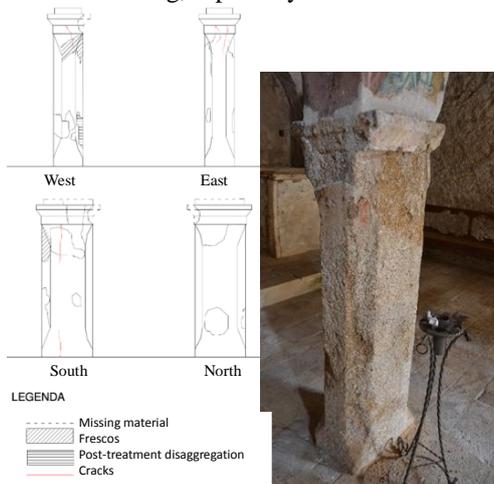
Fig. 2. Crack pattern surveyed on the granite pillar.

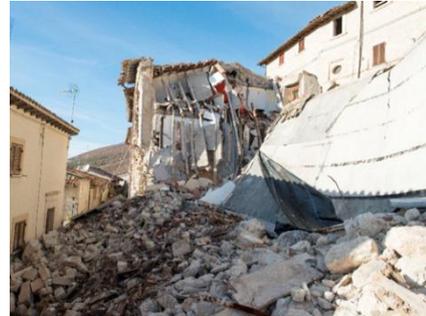
Fig. 3. The collapsed church in October 2016.

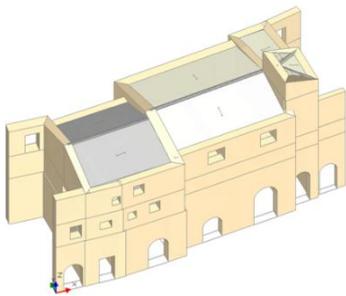
Fig. 4. Model used for pushover analysis.

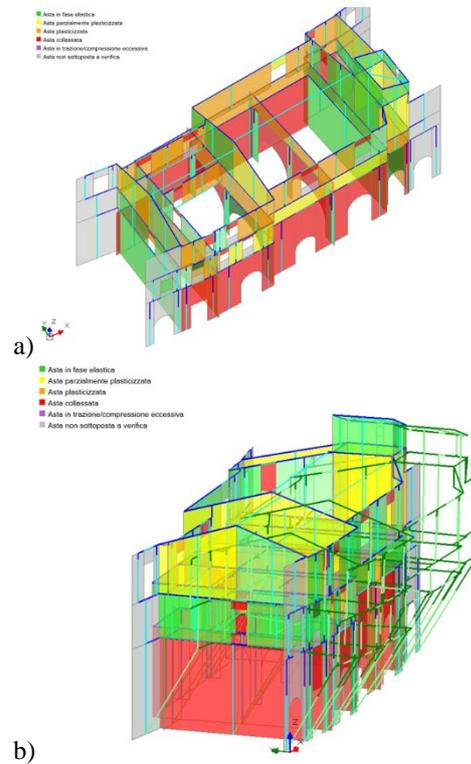
Fig. 5. Results of the pushover analysis: a) direction/sense -Y, b) direction/sense +X.

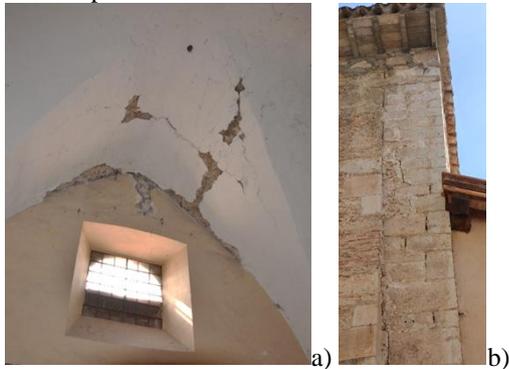
Fig. 9. a) Cracks in the cross vaults, b) detachment of the façade from the lateral bearing wall

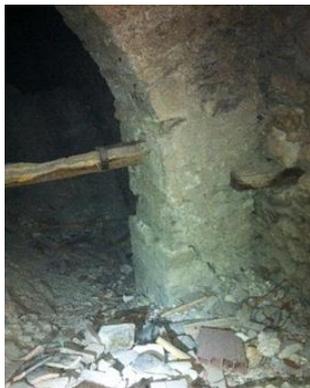
Fig. 10. Serious crack at the abutment of the arch in the area near the old wooden tie.

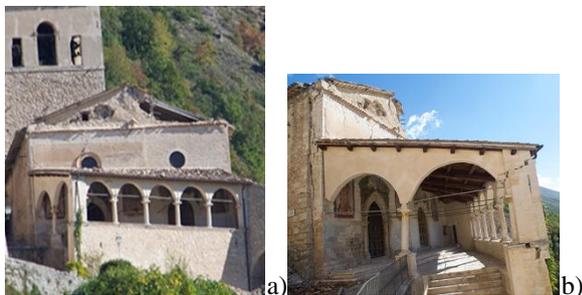
Fig. 11. State of St. Andrew's church after the 26 October earthquake: a) front view, b) detail of the overturning mechanism of the façade.

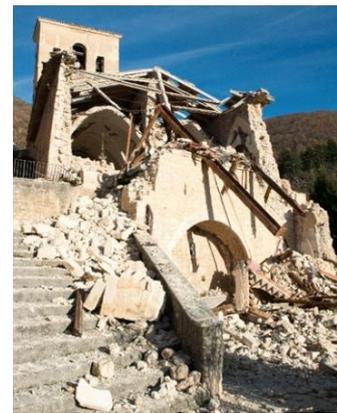
Fig. 12. St. Andrew's church: state following the 30 October earthquake
