Conservation purpose material testing of corrosion products on outdoor bronze statues in Museum Park of Hungarian National Museum

Abstract – A detailed material testing were made before the conservation project of the János Arany statues of Garden of Hungarian National Museum. The scope of the testing to analyse the corrosion layers, and help to develop the best cleaning and protection practice. Samples were taken from more positions and the samples were analyzed by SEM-EDS, XRD, FT-IR methods. This article introduces the results of the testing the relevant effect to the conservation process.

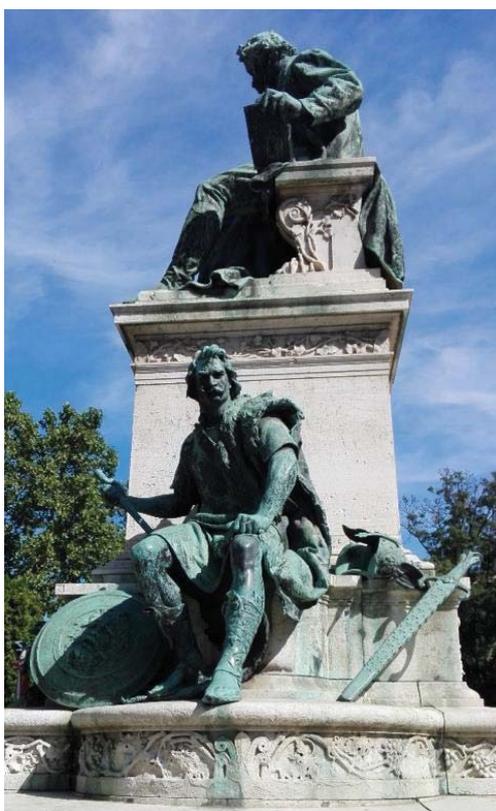
Fig. 2. The status of the statues before the conservation work. The photograph shows the statues of János Arany (up) and Toldi (center). The statues covered by different corrosion layers.

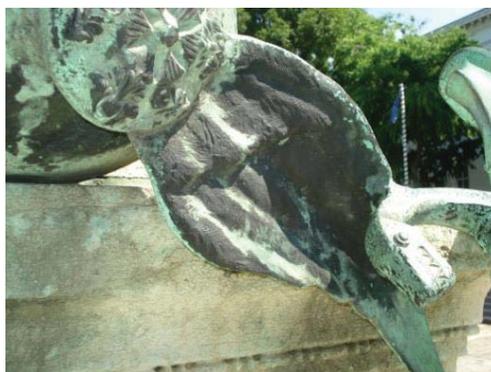
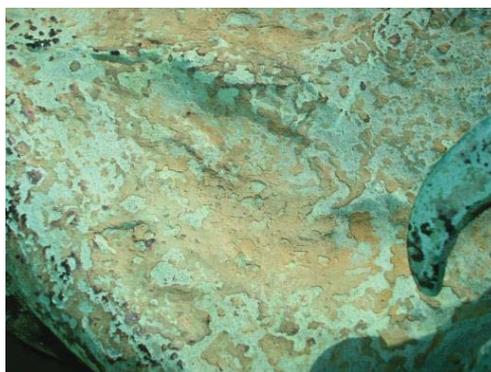
Fig. 3. The different type of layers on the surfaces of status. Upper image shows the black and porous green layer, lower image shows the continuous green and yellow-brown layer.

Basically, four different surface elements were identified (Figure 3):

- surface areas covered by black layer;
- yellow-brown layer;
- porous green layer on the surface;
- continuous green layer on the surface.

The results suggest that it was necessary to remove the black and the yellow-brown layer from the surface of the statue. The green layers could be left over the surface and could be used a patinating process to equalize the outlook of the surface. The black and yellow-brown layers are brittle layers and can easily detach from the statue, so a mechanical cleaning process (blasting) can be used. Neither polymeric nor other substances were found which makes necessary a special chemical treating during the cleaning. Chlorine or other substances also did not found which could have cause problem during the patinating process.

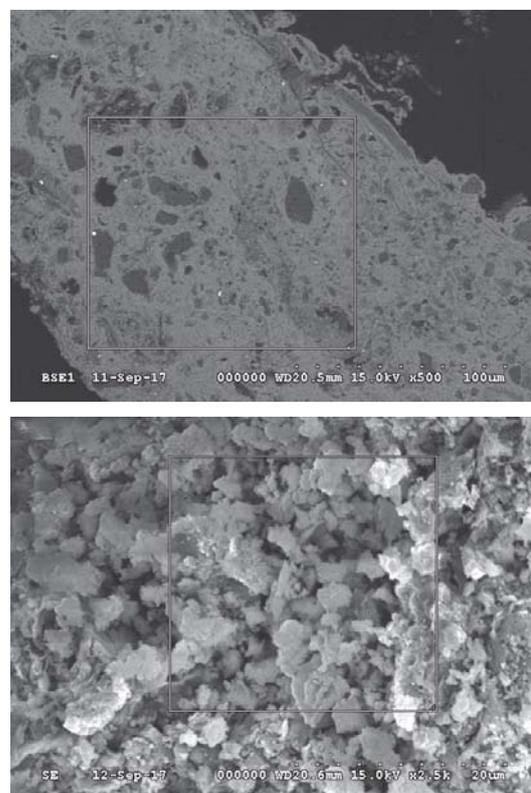
SEM-EDS analysis was performed on selected samples as it was mentioned above. SEM-EDS analysis show the structure of the different layers. The black and yellow-brown layer are particle agglomeration, where different particles have stuck each other from dust (Figure 4). This layer had not had a solid nature.

The green layer is solid, continuous one, where particles are incorporated to a matrix. The black and yellow-brown layers are brittle, and these could easily

detach from the surface. It was suggested to remove it during the conservation process. Additionally, in the case of yellow-brown layer EDS analysis showed high iron content, the color of thin layer come from the iron-oxide content.

Fig. 4. The structure of the continuous green layer (upper micrograph) and the yellow-brown layer (lower micrograph).

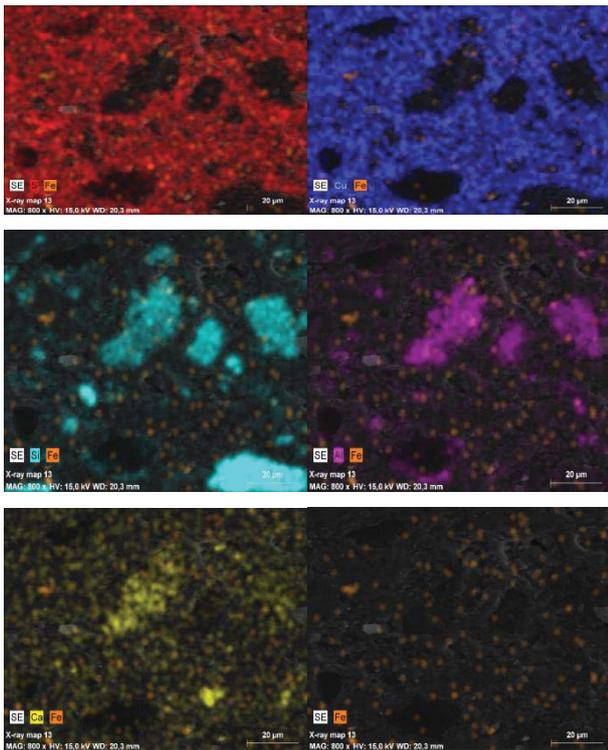
The green layer was also analyzed, and high copper and sulfur content were measured, so this assumed as the patina layer. Figure 5 shows the distribution of different elements, and it reveals that the particles has a large aluminum and silicon content. These elements clearly distinguish the particles and the matrix. Calcium content detected in the particles only, which did not contain sulfur. This shows that the layer either contains calcium, but not in gypsum form, it come from the dust. An interesting observation is that the iron distribution is nearly uniform, and small particles can be seen mainly in the matrix material. Chlorine content was not detected. So, chlorides or other compounds which contains chlorine did not exists on the surface of the statues, or just so minor concentration that won't react during the conservation work. XRD phase analysis was also performed.

Fig. 5. Chemical composition map of the continuous green layer. The matrix is the patina the particles are from dust.

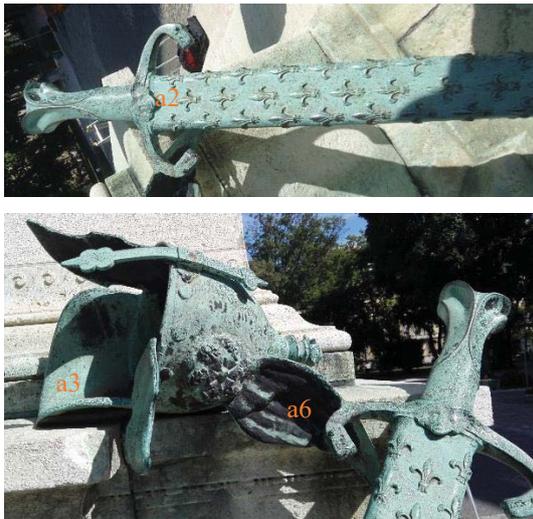
Fig. 6. The position of the sampling. Sample a2 was taken from the green layer of the Toldi's sword. Samples a3 and a6 taken from the surface of Toldi's helmet. Sample a3 represented the green, while a6 taken from the black layer.

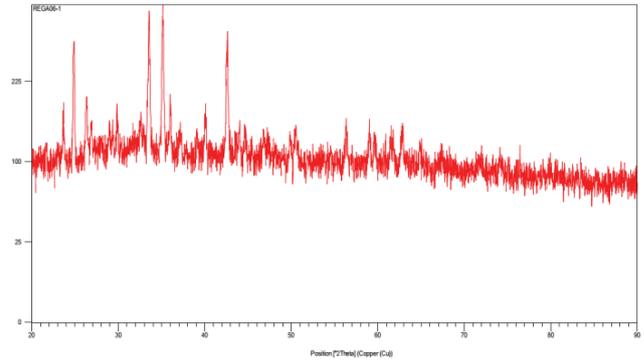
Fig. 7. The XRD spectrum of the green layer a2. This green layer formed on the Toldi's sword. This layer had a solid nature and a similar microstructure as it was shown on Figure 4.

The intensities in the XRD spectrum was low due to the small amount of samples but $\text{CuSO}_4 \cdot 2\text{Cu}(\text{OH})_2$ and $\text{CuSO}_4 \cdot \text{Cu}(\text{OH})_2$ were clearly identified as the main components of the patina layer. $\text{Al}_3\text{Fe}_5\text{O}_{12} + \text{SiO}_2$ identified as dust particles in the matrix at Figure 5. Next to these compounds SnO , CuO_2 and Fe_2O_3 oxides were identified in the sample. Tin and copper oxides are a corrosion product of the raw material. The SEM micrographs revealed the uniform distribution of the iron-oxide particles. The XRD analysis told nothing about the calcium due it's small concentration.

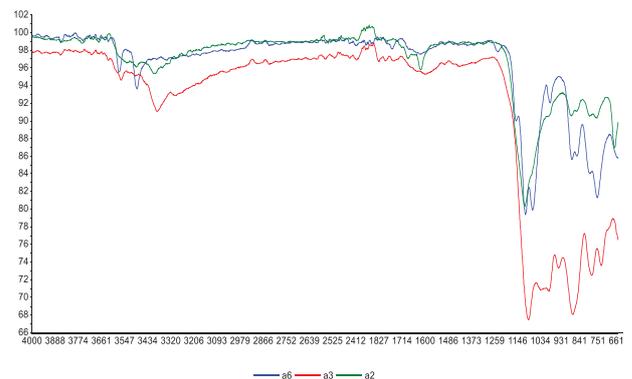
FTIR analysis of the samples (Figure 7) were performed to look for organic material or polymers which could be on the surface probably from an earlier treatment. Without any treatment before the FTIR analysis the samples were examined and neither organic nor polymeric materials were found (Figure 8)

Fig. 8. The FTIR spectra of three different samples of green and black layers. Figure 6 shows the position of the sampling, and Table 1 contains the chemical composition of the samples measured by pXRF.

The FTIR spectra only identified carbonates which either could be a copper compound in the patina layer or calcium-carbonate content of the dust particles. These results show another evidence the absence of gypsum in the layer.

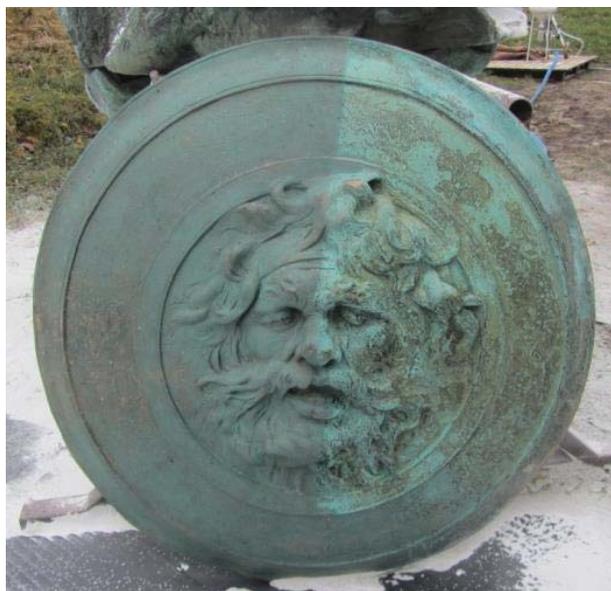
Fig. 9. The Toldi's shield after the cleaning experiment. The left side of the shield was cleaned by particle blasting. The right side of the shield shows the original outlook of the object.

Based on this information cleaning probes were made to choose the best cleaning, blasting agent. The results of a NaHCO_3 particles blasting is showed by Figure 9.

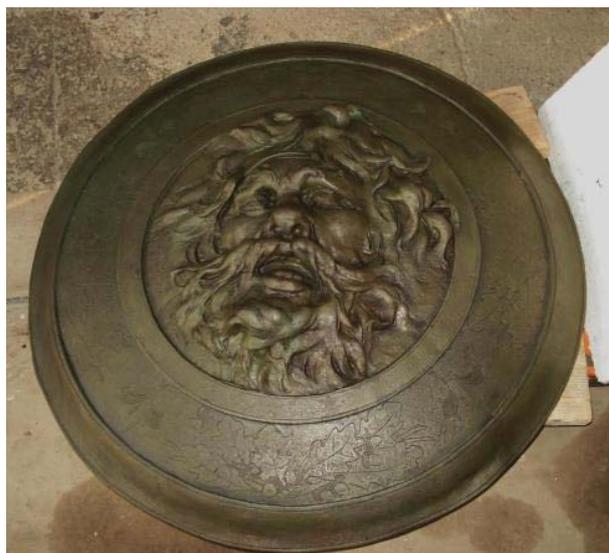
Fig 10. The cleaned and patinated shield. The leaf symbols revealed after the cleaning and patinating process which were hidden by the removed corrosion layers.

The chosen cleaning process removes all undesired material from the surface, therefore other chemical treatment was not necessary just the patinating process (Figure 10). After the patinating process a protective thin resin layer was also applied which did not change the outlook of the statues just gives an additional protection.
