Testing, diagnosis and rectification of high dissipation factor in large power transformer

Somil Joshi¹, Girish Pathak²

¹CGPISL, Mandideep, India, somil.joshi@cglobal.com, 9041013650

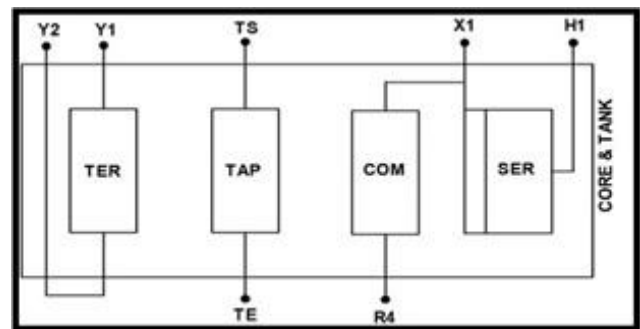
In Table-2, H1 is high voltage terminal of SERIES winding, X1 is COMMON winding terminal, and R4 terminal is end of SERIES + COMMON winding. This R4 terminal is separated from TAP winding start TS, TE is end of TAP winding, Y1 and Y2 are start and finish of TERTIARY winding respectively. The description of winding terminals are shown in Fig-3.

Fig-3: Arrangement of winding terminals during additional dissipation factor test.

For clear localization and identification of faulty winding insulation section, an additional dissipation measurement was performed. Since, it is an auto-transformer with neutral end tap winding. The tap winding was isolated from SERIES+COMMON winding. The modifications are shown in Fig-3. After separation of TAP winding from SERIES+COMMON winding dissipation factor measurements was performed as per Table-2 given below.

winding is combination of SERIES & COMMON winding electrically in series with TAP winding. Hence, modification as described Fig-3 was made and measurement was performed as per Table-2 at 5 kV. Results of additional power factor test are reported in Table-6.

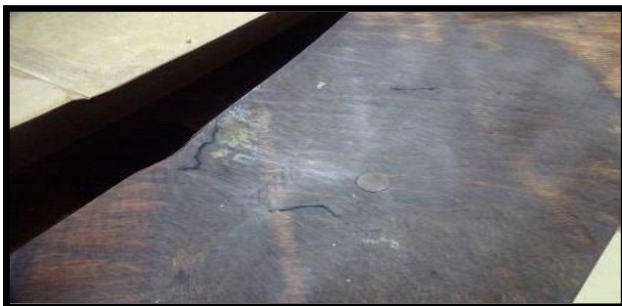
Below are some pictures after dismantling SERIES+COMMON and TAP winding. The perma wood coil support platform was found broken and burnt.

Fig-4: Broken and burn marks were found on permawood ring of coil support platform.

The burnt portion of insulation was making entire insulation conducting in nature. Thus a sharp rise in

resistive component of leakage current (I_r) was observed in Table-4 when supply voltage was gradually increased from 1 to 10 kV.

Thus, additional dissipation factor test performed as per Table-2 proved helpful in identification of faulty insulation component. These types of faults in insulation are initially minor in nature. But, continued operation and ignorance of damaged insulation may lead to blackouts and loss of generation. After replacing the perma wood ring, the transformer was again re-assembled, refurbished by CGPISL T-3 division norms and was offered for final routine testing as per IEC 60076. During, routine test dissipation factor measurement was performed as per Table-1. The measured values are shown in Table-7.

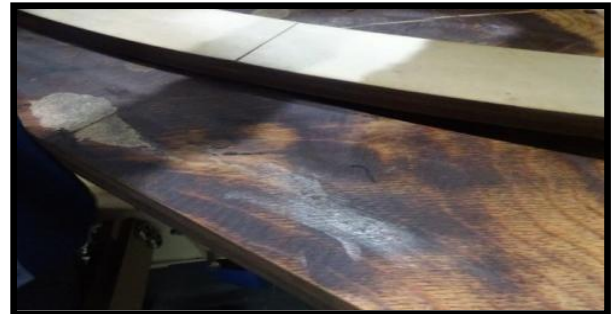
Fig-5: Burn marks on other side of the permawood ring.

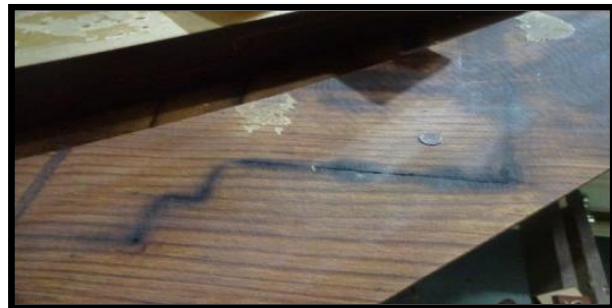
Fig-6: Formation of creep path due to continuous

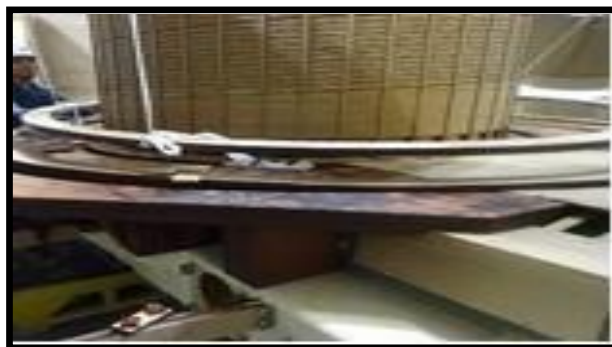
Fig-7: Series + Common winding during dismantling.
