Study the conservation state of the façade of the Basilica of Santa Croce (Lecce- Italy) using ground-penetrating radar

Abstract – The basilica of Santa Croce in Lecce is a baroque church internationally well known; the starting point for this research was the evidence that some structures of the façade are more damaged and present signs of subsidence. The possible causes of damages can be: i) buried structures or subsurface anomalies; ii) not suitable microclimatic conditions; iii) deposition of pollutants. In order to study the first cause of damage geophysical survey, using ground-penetrating radar (GPR) was performed. This allow to obtain information on buried structures or to locate and identify anomalies related to a restoration intervention carried out in the 80s.

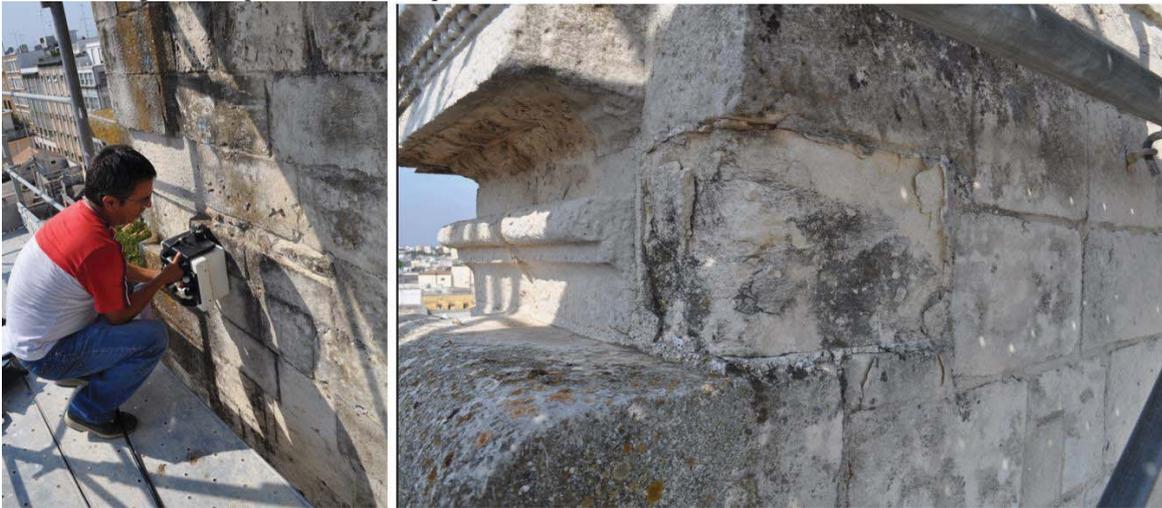
The GPR survey was performed using a RIS MF Hi Mod by IDS GeoRadar and deploying antennas of 900MHz and 2000 MHz centre frequency (Fig. 2). 150 georadar profiles were performed, 99 of which with a 900 MHz antenna and 51 with a 2000 MHz antenna. The location of the profiles is shown in fig. 3. All profiles were acquired with 512

Fig. 2. Phase of the GPR data acquisition. On the right side of the photo, a detail of the status of conservation

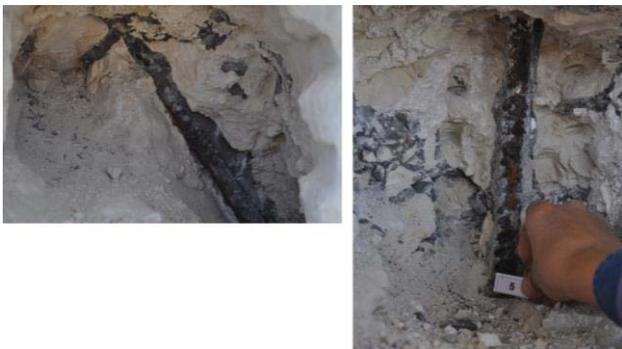
Despite having used antennas with frequencies between 900 and 2000 MHz the spatial resolution was not always able to discriminate the presence or absence of iron bars inside the perforations. The density contrast existing between the different materials, such as stone, concrete / resin, iron, and the net of voids is not always sufficient to discriminate in the field the presence of voids, perforations with cement grout, or iron bars. The post-acquisition data processing was therefore fundamental, which allowed us to obtain satisfactory and useful results for the intended purpose. From these results and the direct observations (Fig. 7) it is clear that the declared location of the irons inserted in the structure, in the intervention carried out in the 80's, differs from the one actually found, not so much for the spatial distribution of the reinforcements as for their length.

Fig. 7. Photos of the excavation done after the results of geophysics
